# WROUGHT IRON *for* UNDERGROUND SERVICES

A TECHNICAL BULLETIN PREPARED BY THE ENGINEERING SERVICE DEPARTMENT

**A. M. BYERS COMPANY • PITTSBURGH, PA.**

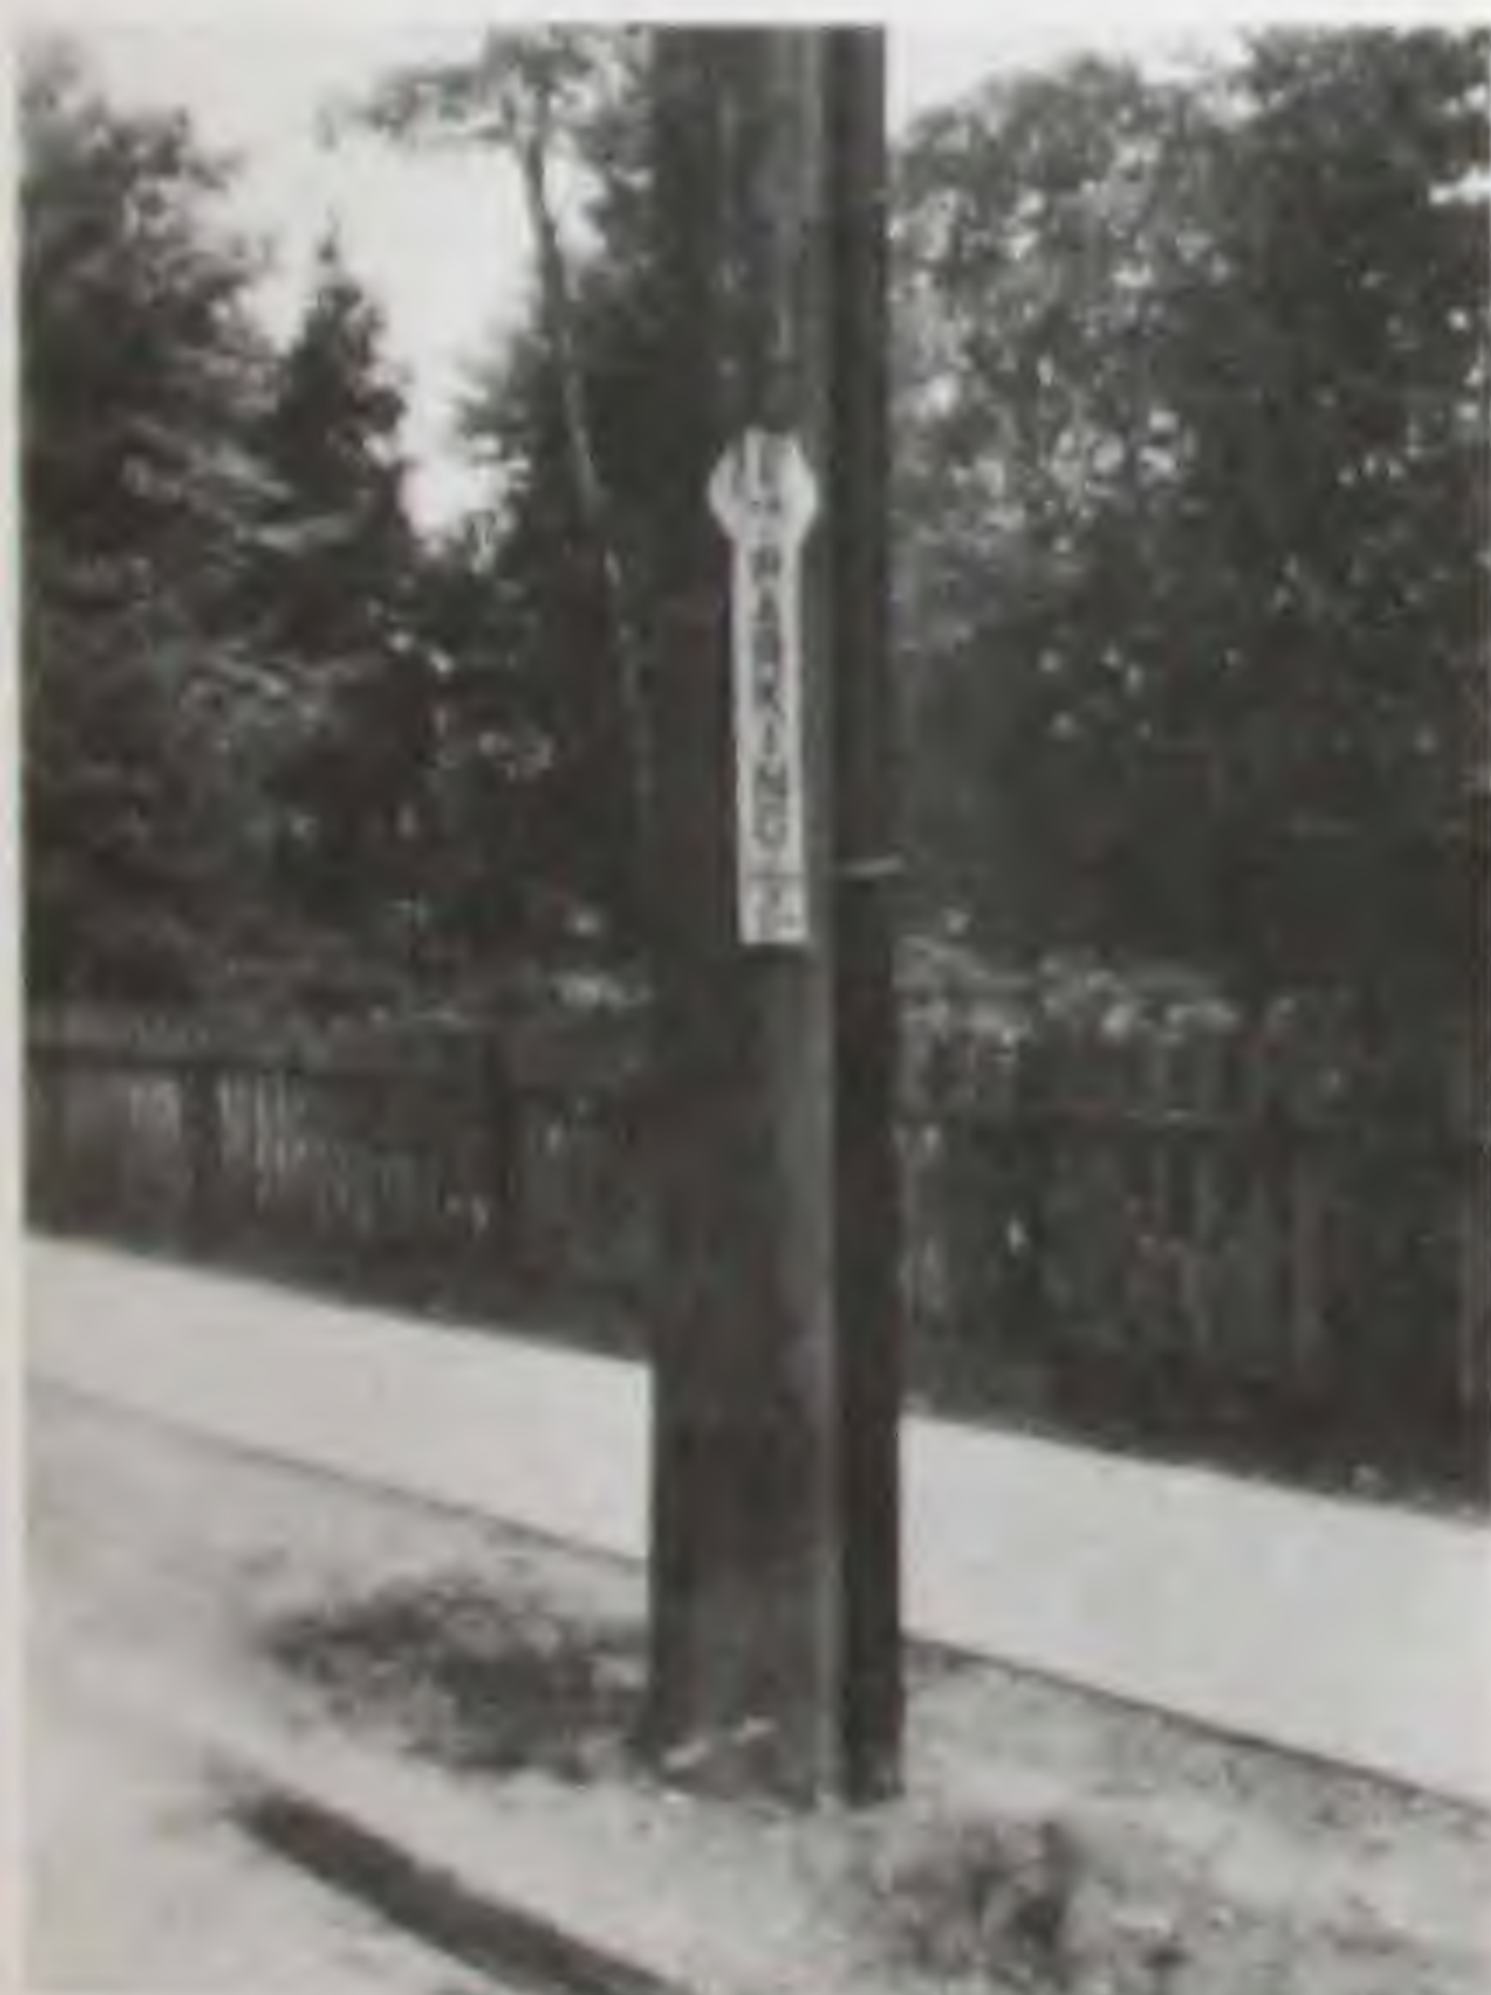
Fig. 57

Chicopee Electric Light Company, Chicopee, Mass., has found that wrought iron lasts longer than other ferrous metals for this service, and one of their installations is shown in Fig. 57.

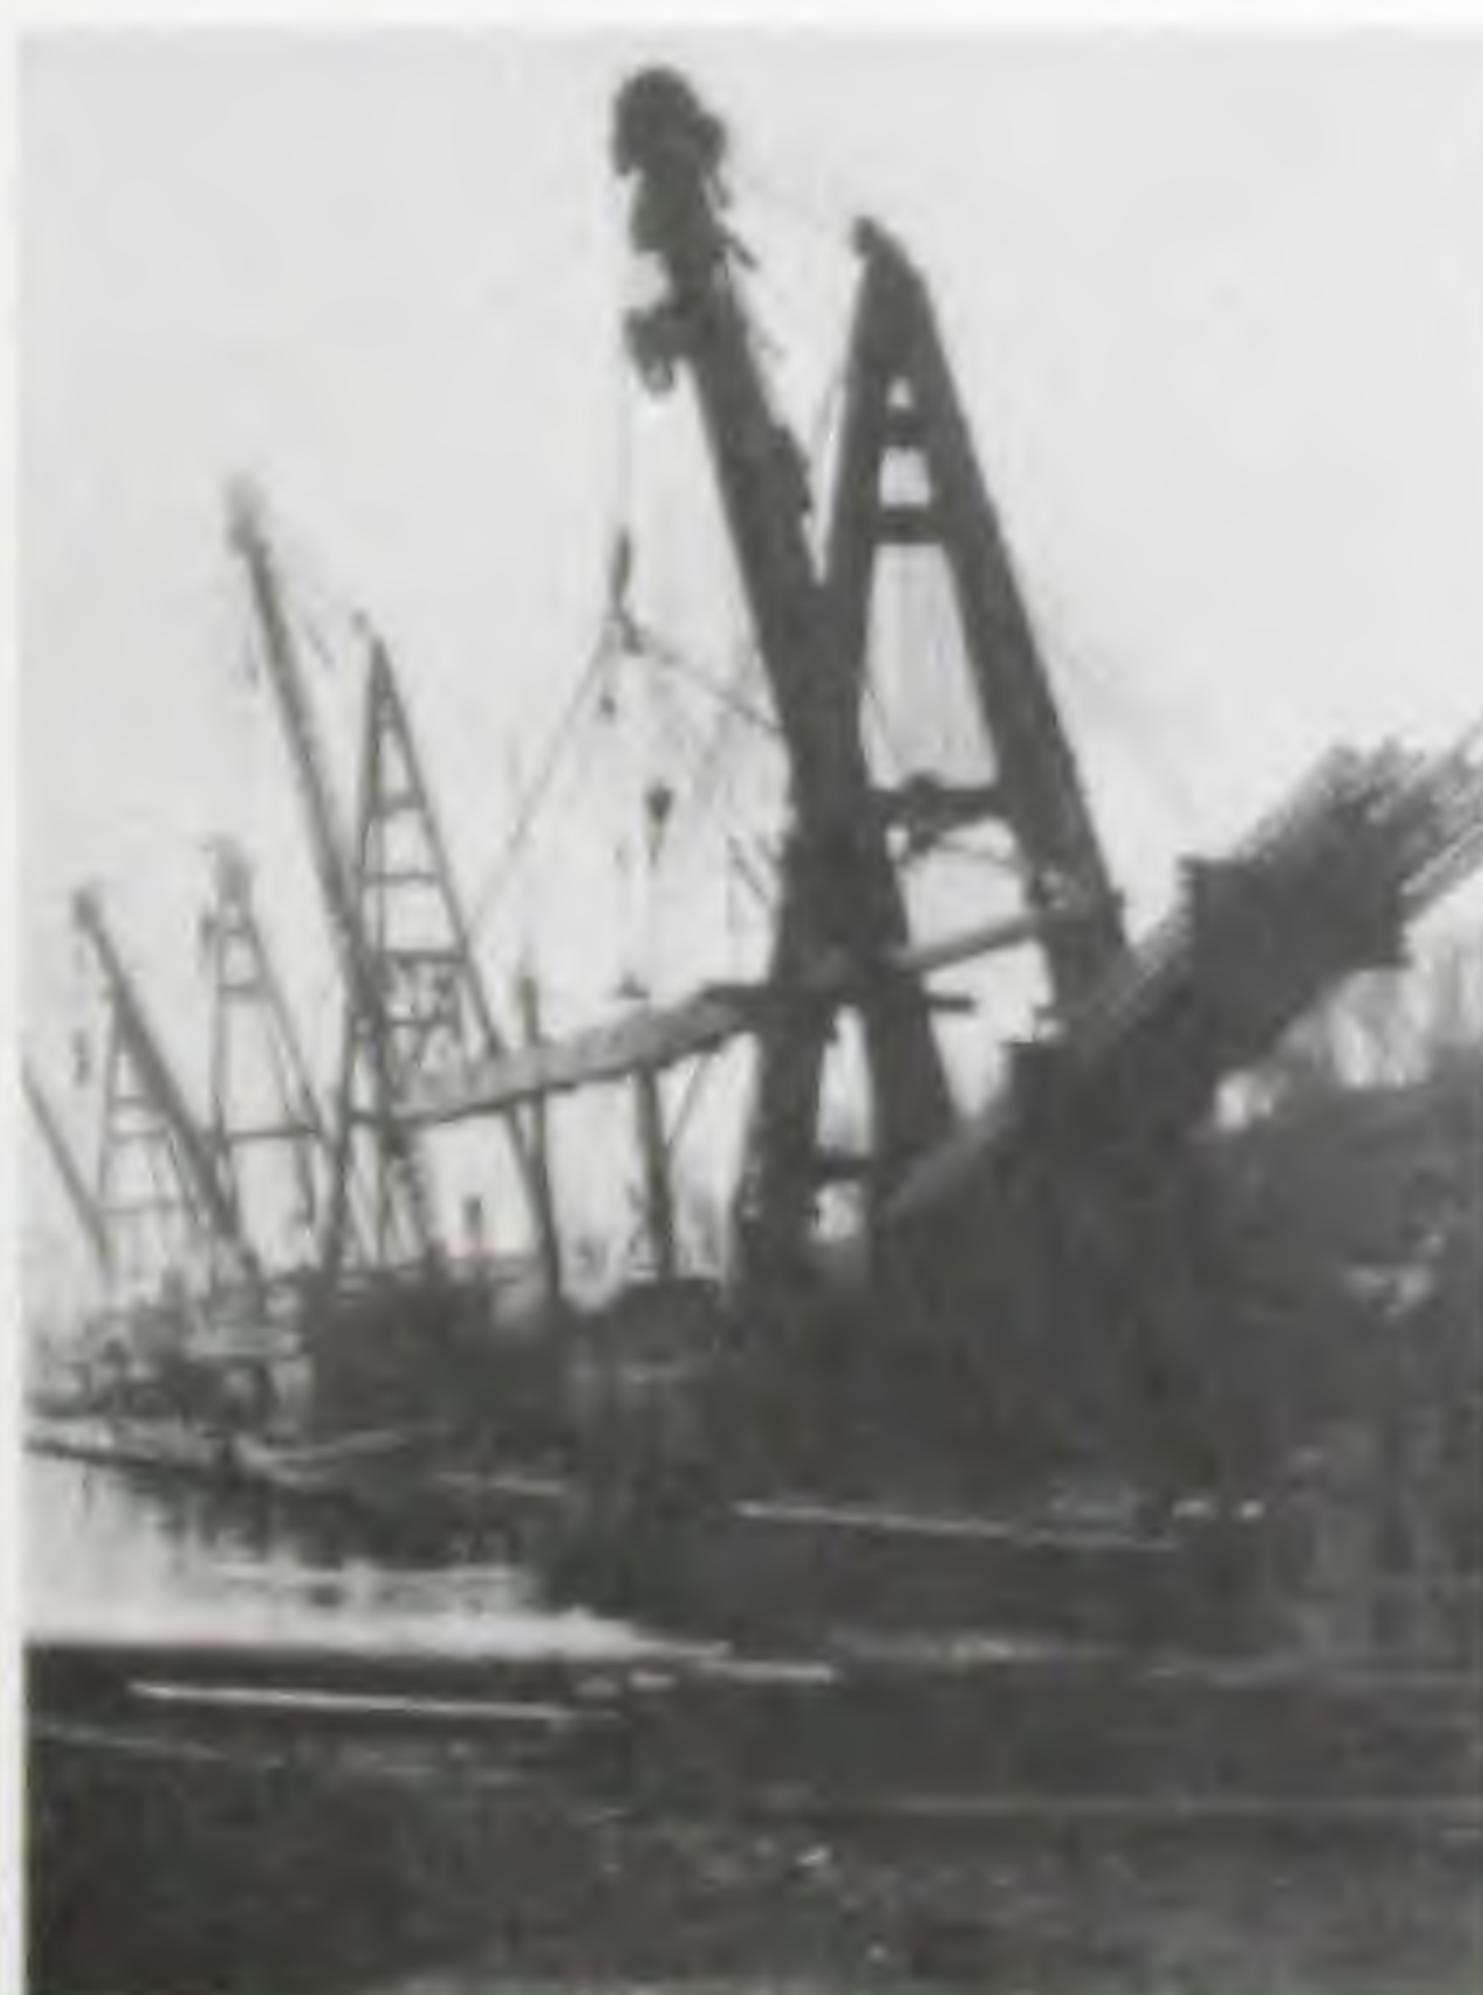
About twelve years ago, the New York Central Railroad was faced with the problem of crossing this stream with the high tension lines to supply the West Side Improvement being constructed by the railroad. Fig. 58 shows the entire group of thirty-six 4" extra heavy wrought iron conduits being lowered into the 32 ft. deep channel. Recent conversations with engineers in the engineering and maintenance departments of the railroad revealed that the installation has been entirely satisfactory.
